# Mapping of Abandoned Mine Site Related Tailings Storage Facilities in Gauteng Province, South Africa

I. Tsotetsi and M. Mpanza

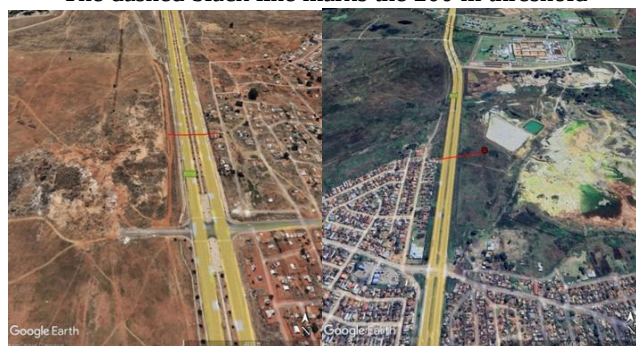
Fig 2: a) Primrose TSF

b) Apex mining TSF

The results showed significant variation, with some TSFs located extremely close to specific residential areas while others were further away. For example, the Primrose TSF is only 71.4 m from houses in Primrose (Germiston), while the Sandsales Quarry TSF lies 66 m from homes in Edenvale. The Rand Lease TSF is situated 79.82 m from the settlement of Roodepoort, Slovoville TSF is 55.18 m from Slovoville, and the Apex Mining TSF is 179 m from residences in Benoni. By contrast, TSFs such as Modderfontein East (350.46 m from Modderfontein), Spaarwater (354.60 m from Springs), Olifantsfontein Mine 2 (404.88 m from Olifantsfontein) and Sub-Nigel Crushers (414.13 m from Nigel) were found to be located further from residential areas. These findings revealed not only the widespread presence of abandoned TSFs across Gauteng but also their alarming closeness to established human settlements in certain regions.

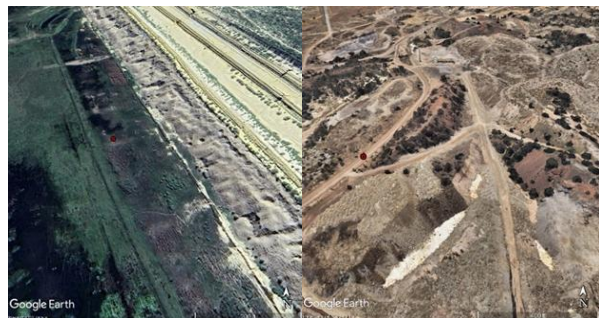
Fig 3: a) Leeuwkuil Quarry TS b) Luipaardsvlei gullies TSF

At the Leeuwkuil Quarry, erosion is more severe. There are signs of gully erosion, where water has cut deep channels, as well as bank erosion, where parts of the quarry walls are collapsing. This is an indication of the age of the dump and means this dump has been long standing in the area, these signs point to slope instability. The erosion is concentrated in areas where stormwater runoff is strongest. The causes include uncontrolled surface water, clearing of vegetation during mining, and sandy or silty soils that erode quickly once disturbed (Stocking and Murnaghan, 2001; Boardman, 2022). The Luipaardsvlei site shows the most advanced stage, with

large and branching gullies. These gullies are deep and wide and are spreading upslope through headward erosion. The damage is extensive, and large portions of land are no longer usable. The main causes are uncontrolled stormwater from nearby mine dumps, absence of vegetation, and soils that break down rapidly once exposed, most likely clay-rich soils (Nyamadzawo et al., 2013; Morgan, 2005).

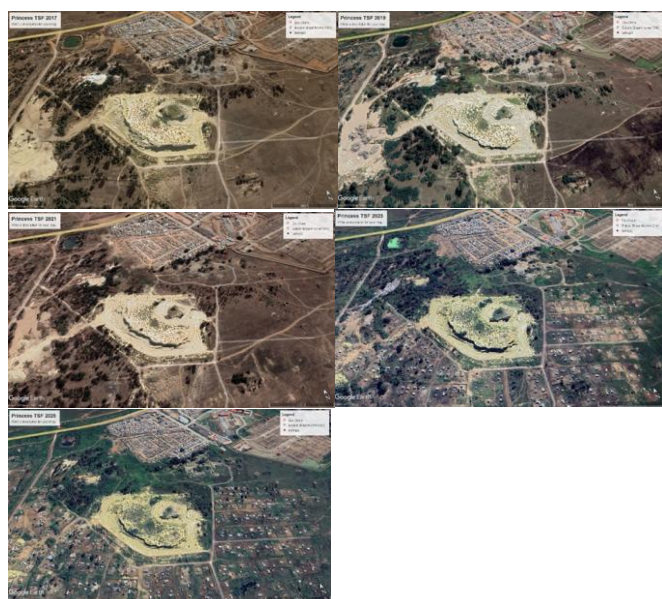
Fig 4: Princess TSF from 2017 to 2025

The Princess TSF, located in Roodepoort on the western mining belt of Johannesburg, is classified in this study as an abandoned facility, since there is no evidence of active management or rehabilitation. The dump lies in close proximity to residential areas, falling well within the 200-metre threshold adopted in this study, and is therefore considered a high-priority site for rehabilitation. Visual inspection through Google Earth Pro imagery shows that the Princess TSF remains largely barren, with only limited patches of natural regrowth. Based on the vegetation classification applied in this study, it falls within the sparsely vegetated to barren category, which reflects instability and elevated dust risk. Change detection over the past five years confirms that there has been little meaningful improvement in vegetation cover, pointing to the absence of formal rehabilitation efforts. Its location near densely populated areas, combined with poor surface stability, means that the Princess TSF continues to pose significant environmental and social risks, including dust pollution, erosion, and possible contamination of surrounding land and water resources.

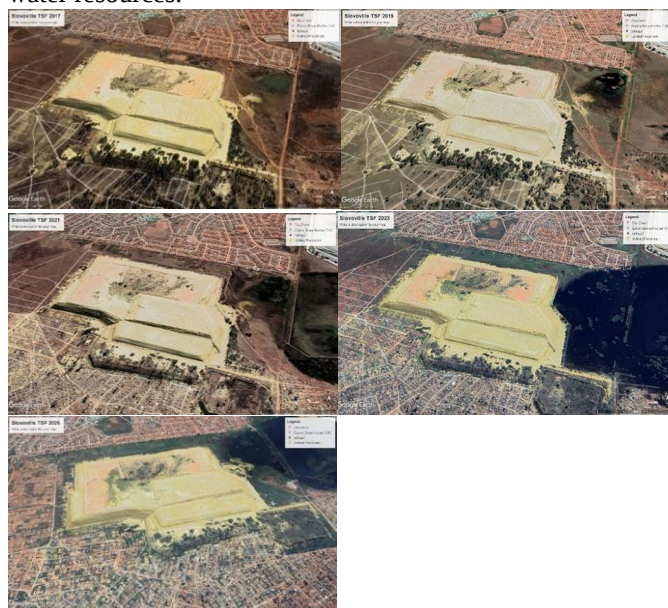
Fig 5: Slovoville from 2017 to 2025

Similarly, the Slovoville TSF near Soweto is also classified as an abandoned facility. It is located immediately adjacent to the settlement of Slovoville, with residential houses extending to the foot of the dump, placing it firmly in the high-priority category. Satellite imagery shows that the Slovoville TSF is in a degraded condition, with large, exposed surfaces and evidence of erosion. Sparse patches of vegetation are present, but they do not provide meaningful surface stability. Historical imagery further confirms that the TSF has remained largely unrehabilitated for at least the past five years. Like the Princess TSF, its location is close to communities combined with its barren condition, it exposes residents to risks of dust inhalation, surface instability and possible contamination of soils and water sources.
